Bloomfield Hills Board Meeting
Thursday, May 22, 2025.
Gibsonia Baptist Church Meeting Hall
5440 US Highway 98 North Lakeland, FL.33809

MINUTES

Pond 100 Outfall Remediation

Reference: Geotechnical Letter Report
Bloomfield Hills Pond 100
SWC of Gibsonia-Galloway Rd and US Hwy 98
Polk County, Florida
UES Project No. 0830.2500051

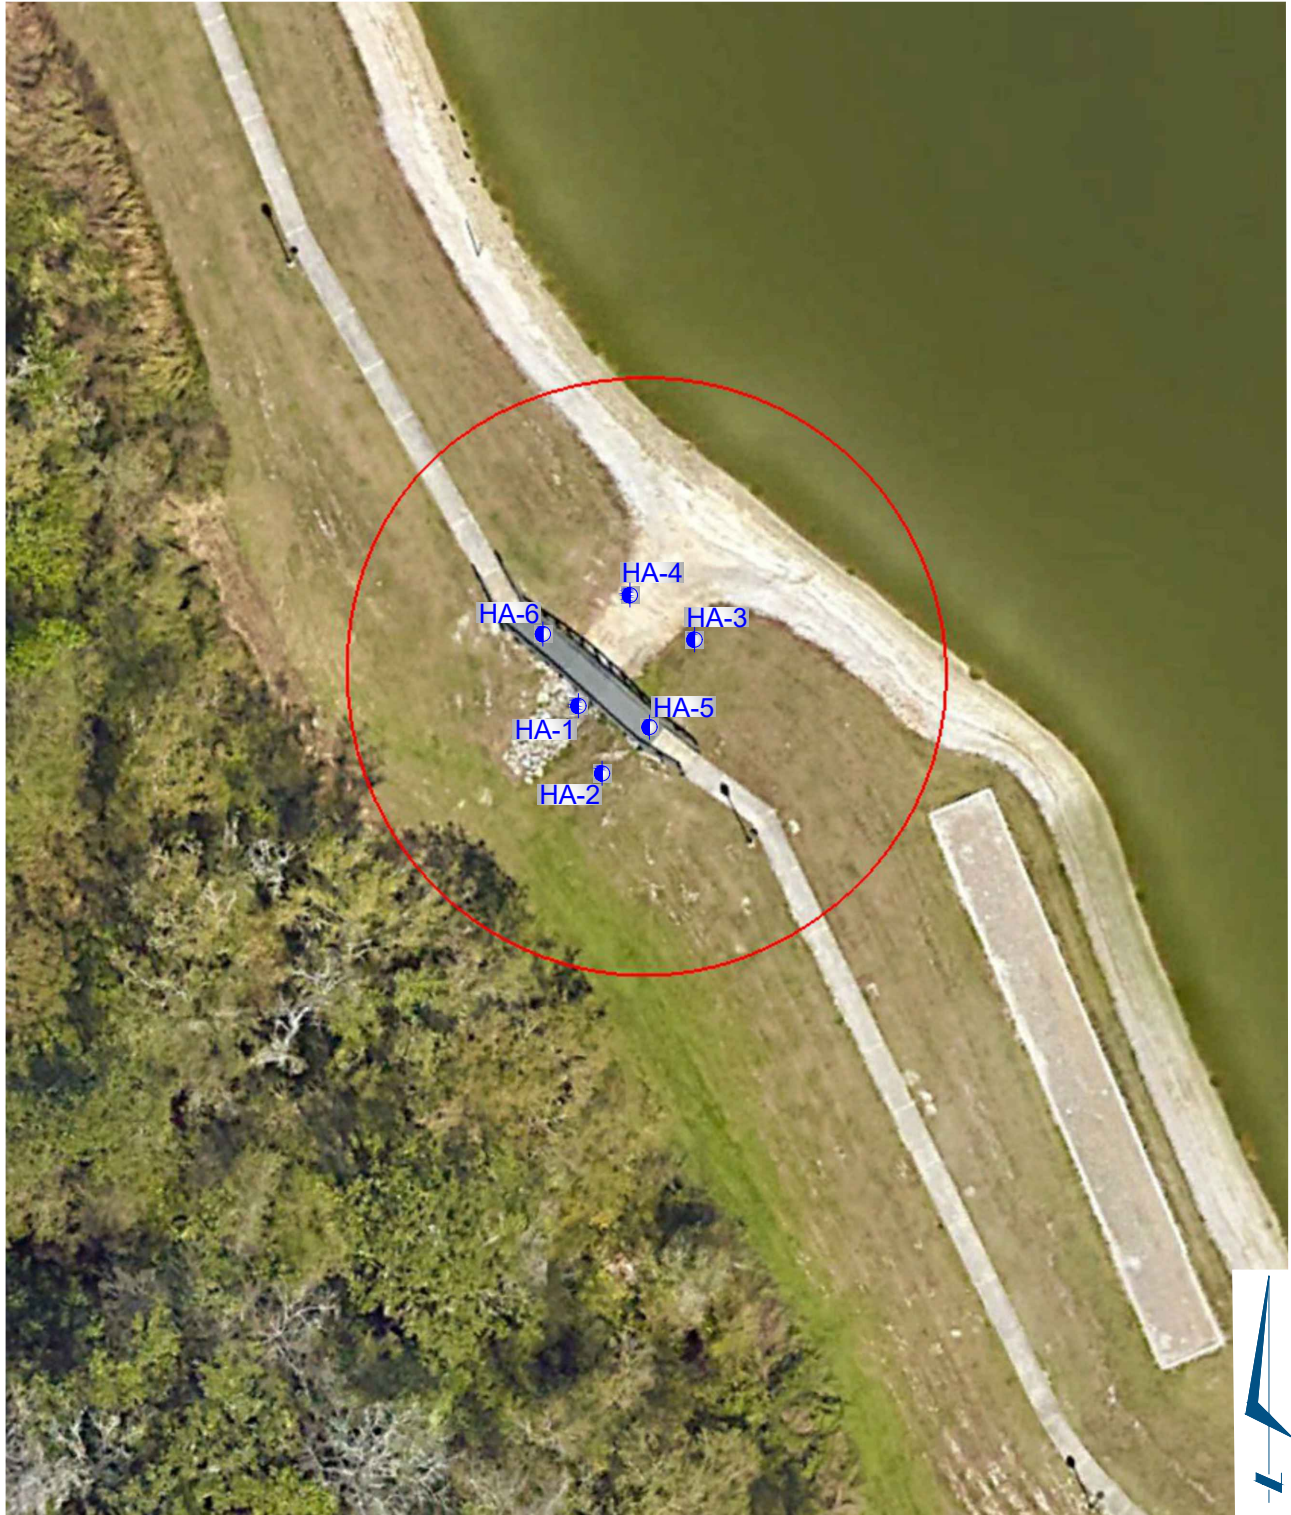
FIGURE
1

During our field exploration, UES personnel performed shallow hand auger borings at the base of the previous control structure location. Soil samples were also collected from the washed-out portion of the embankment side to evaluate the embankment soils. The approximate test locations are shown on **Figure 1**.

Groundwater was encountered at depths of about 1 to 2 feet below grade within the hand auger borings performed near the base of the failed structure.

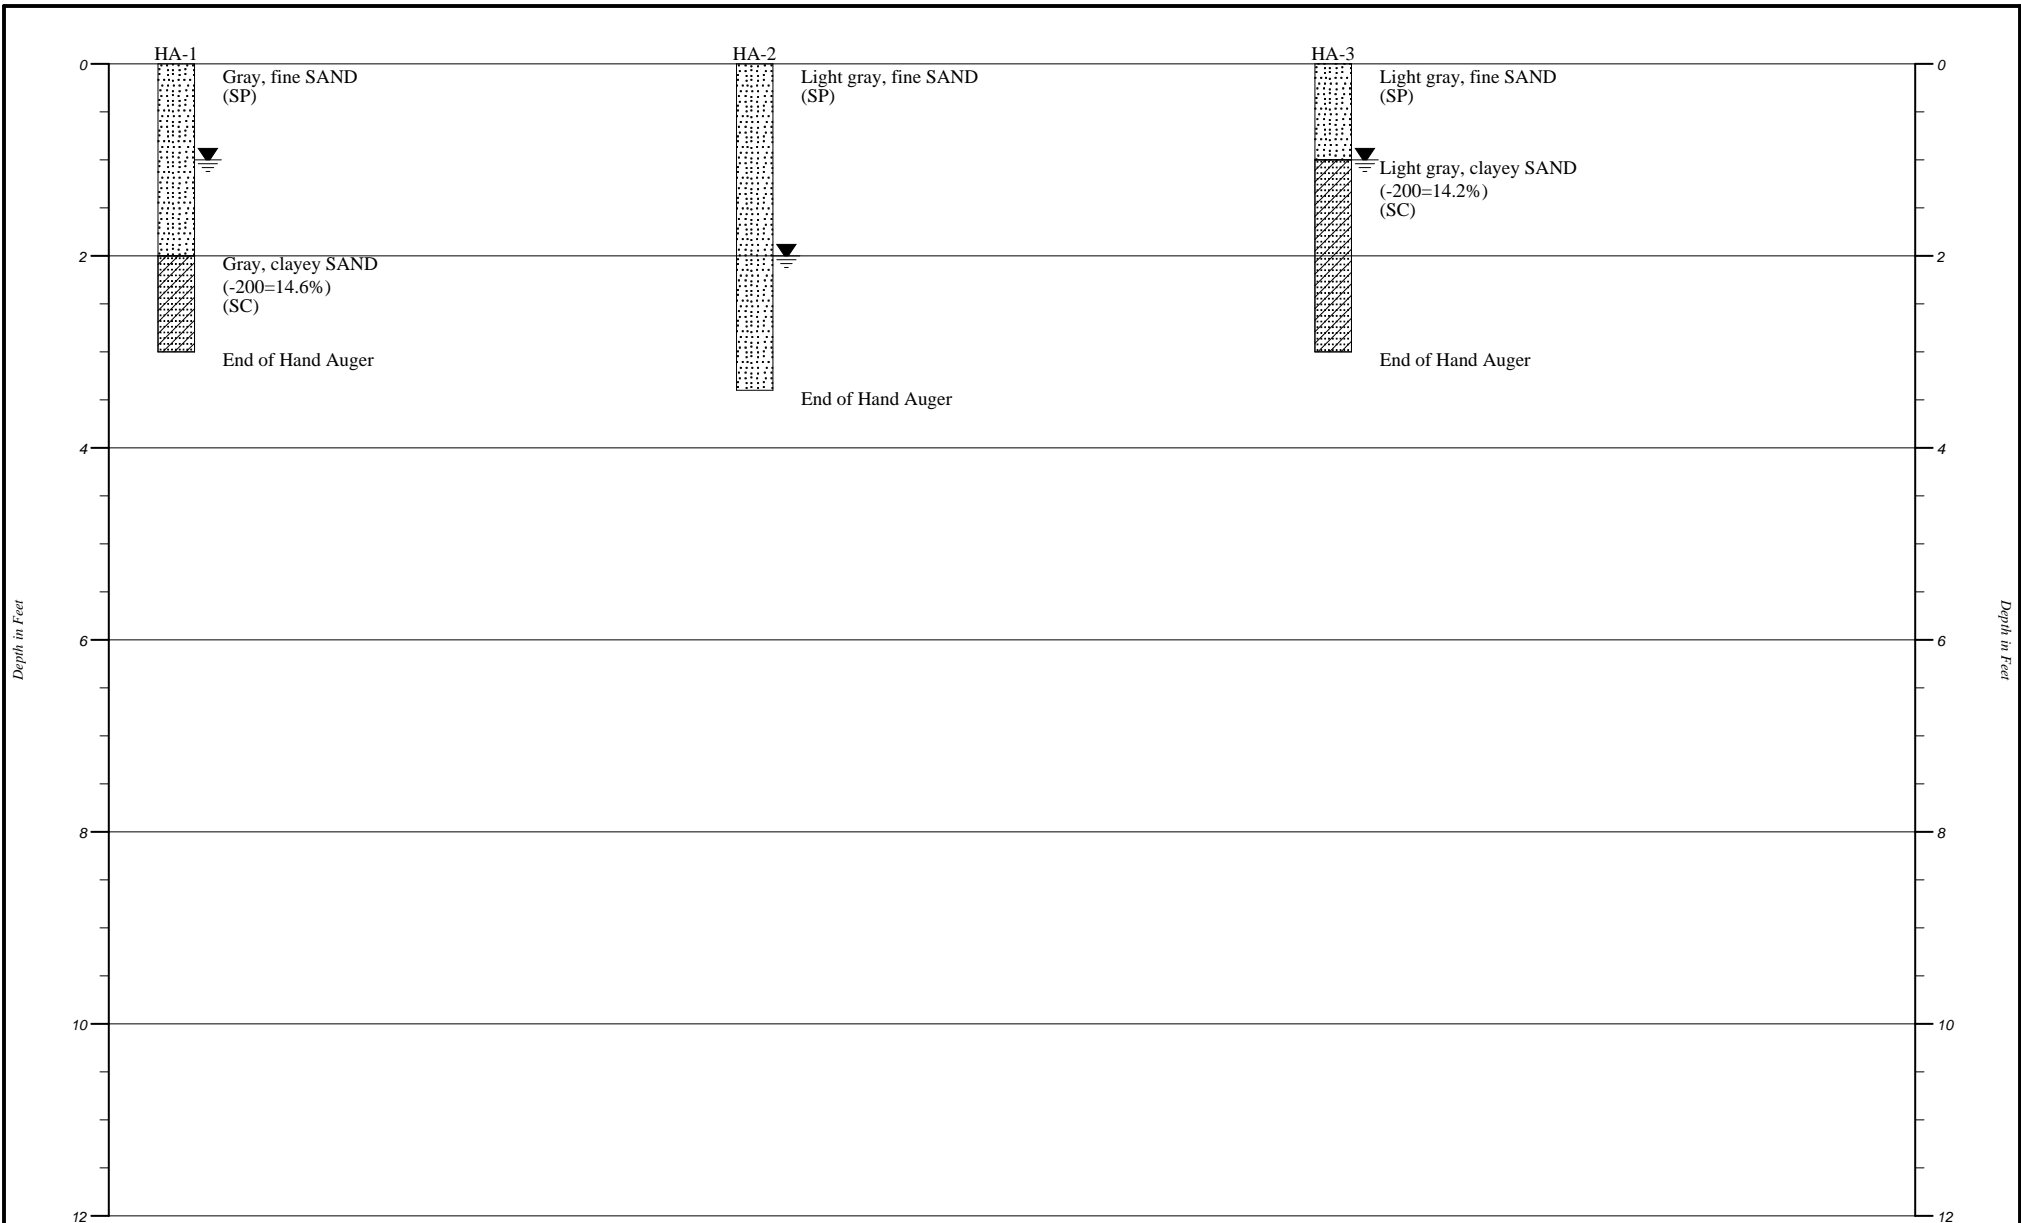
UES		
AUGER BORING/TEST PIT PROFILES		
HORIZONTAL SCALE:	DRAWN BY/APPROVED BY	DATE PERFORMED
VERTICAL SCALE: 1"=2'	MM/SC	4/9/2025
Bloomfield Hills Pond 110		
PROJECT NO. 0830.2500051

Our soil borings performed near the base of the control structure encountered soils consisting of fine sand (SP) and clayey sand (SC) from existing grade to boring termination at about 3 to 3.5 feet below grade. The results of laboratory testing performed on samples of the clayey sand (SC) soils ranged from 14.2 to 27.0 percent.

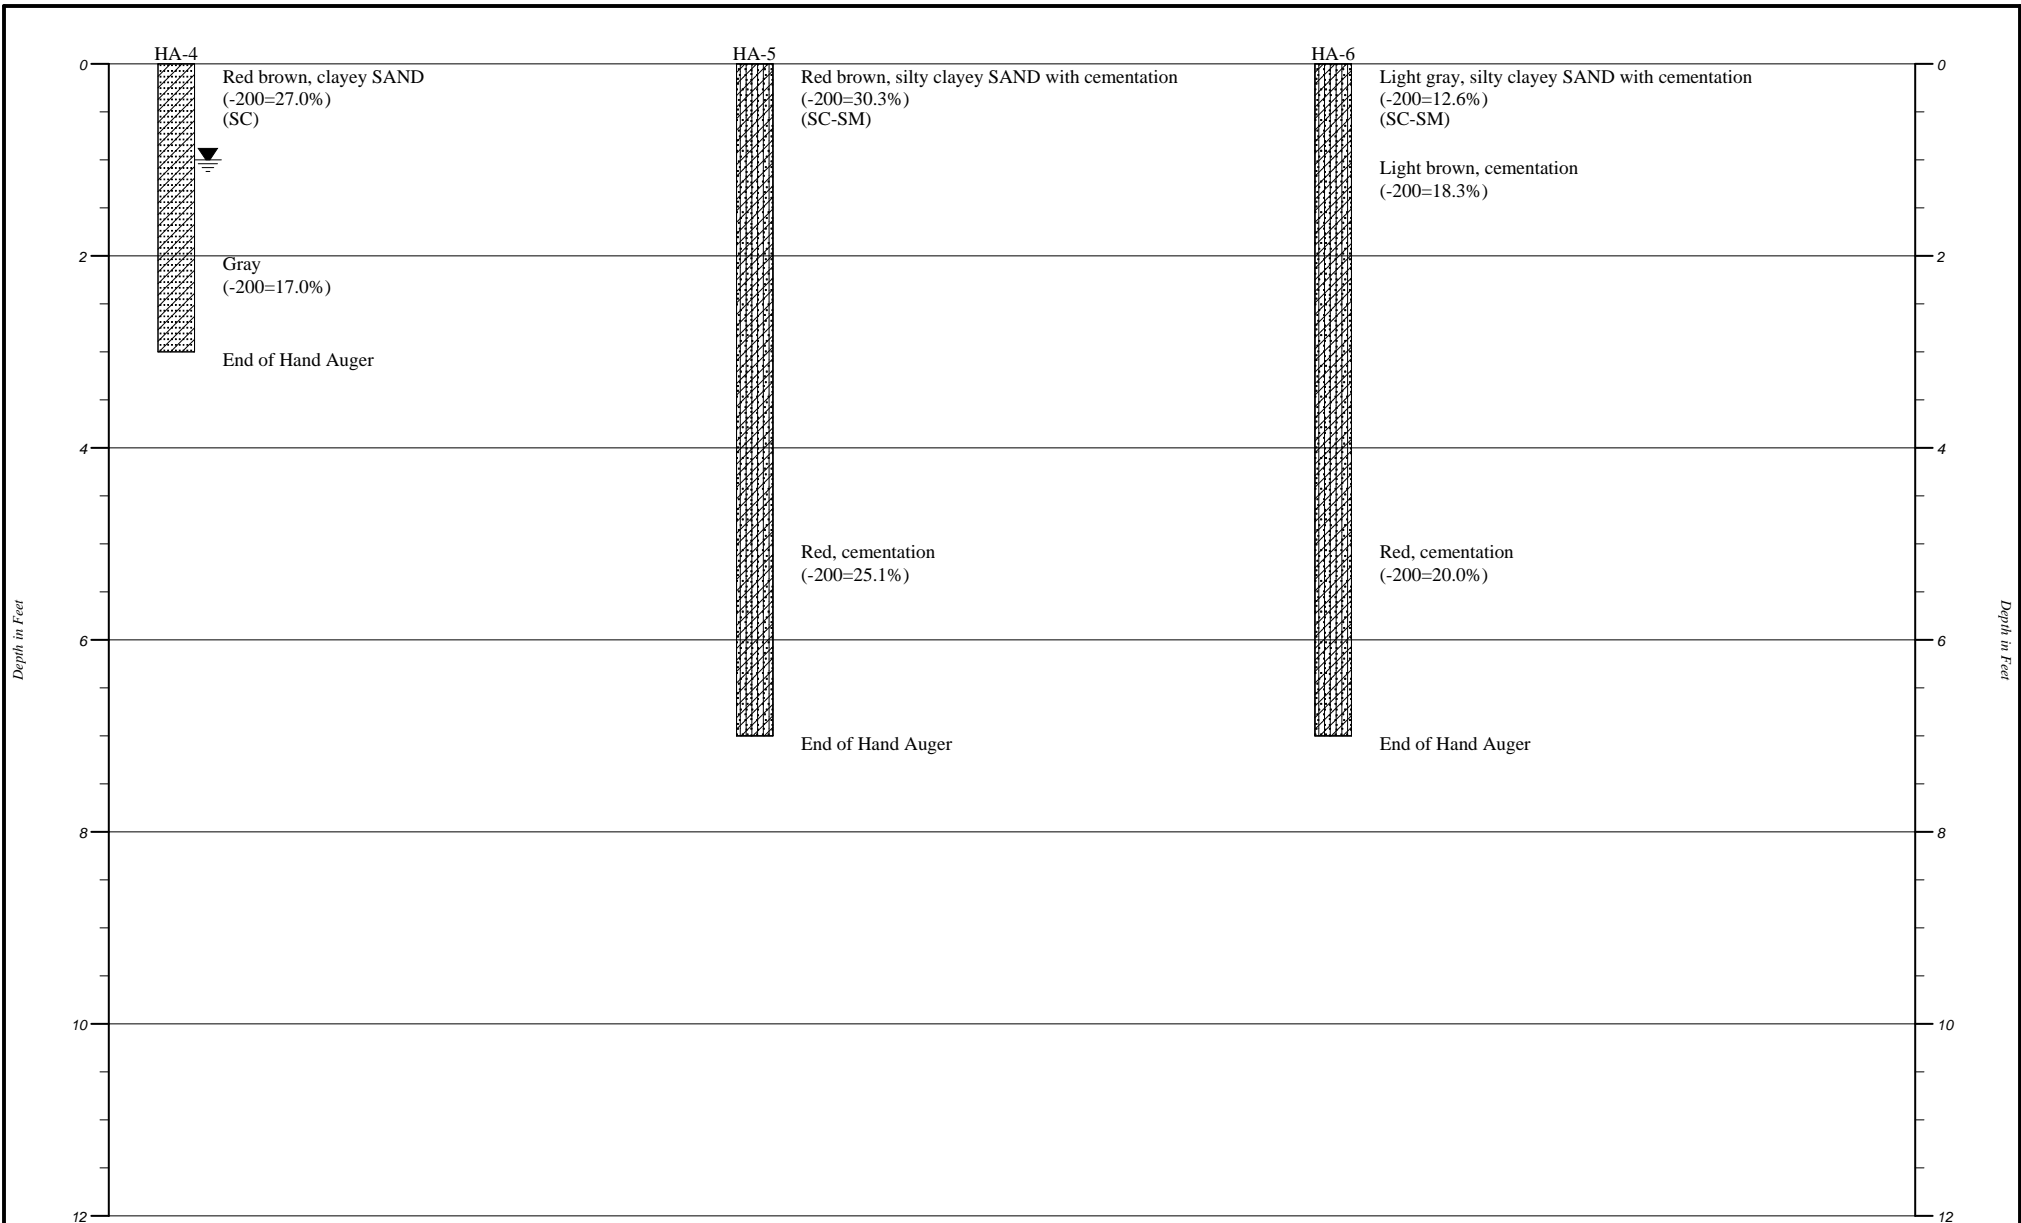
UES		
AUGER BORING/TEST PIT PROFILES		
HORIZONTAL SCALE:	DRAWN BY/APPROVED BY	DATE PERFORMED
VERTICAL SCALE: 1"=2'	MM/SC	4/9/2025
Bloomfield Hills Pond 110		
PROJECT NO. 0830.2500051

Soil samples collected from the side of the embankment near the failure indicated that the soils consisted of cemented silt to clayey sands (SM/SC) from the crest to base of the embankment. The results of laboratory testing conducted on the embankment soils indicated fines contents ranged from 12.6 to 30.3 percent.
